Water Quality Management Plan for 2005 Water Year

2006 Water Quality Implementation Report

*Provo River, Deer Creek Reservoir
and Jordanelle Reservoir*

DESERT ROSE ENVIRONMENTAL, LLC

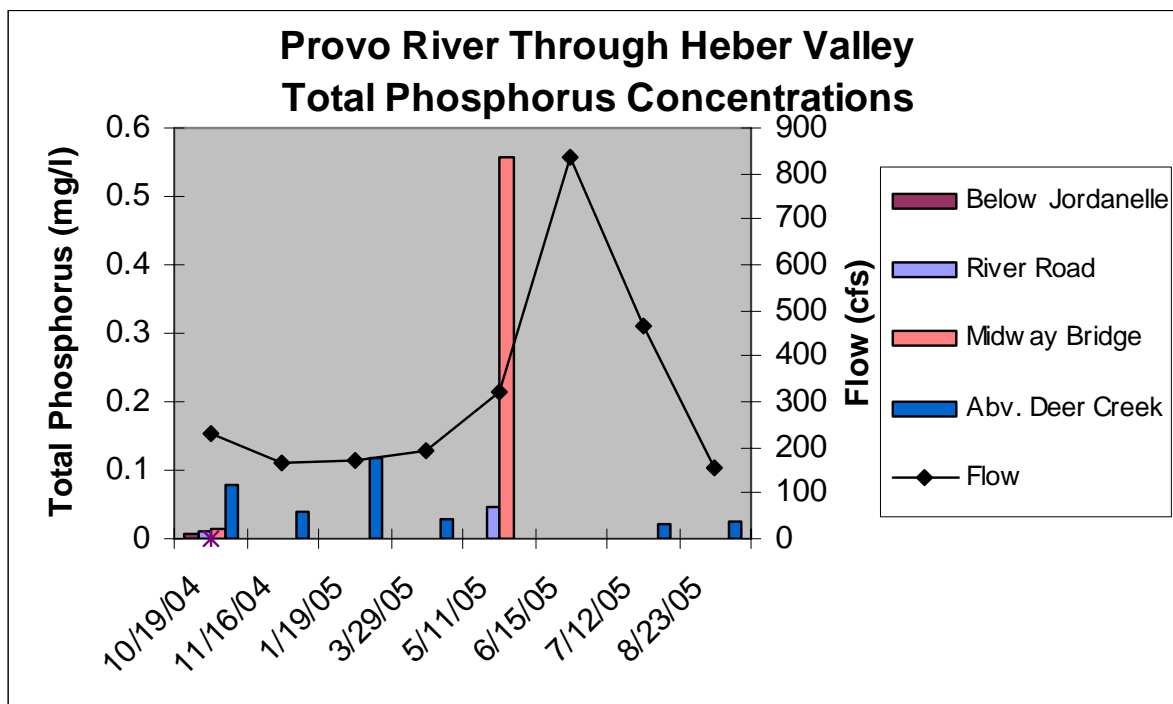
Figure 5- 2 Provo River Through Heber Valley Total Phosphorus Concentrations

Figure 5- 2 and Figure 5- 3 compare the concentrations of Total Phosphorus and Total Suspended Solids at various locations on the Provo River through the Heber Valley. Generally, only the station above Deer Creek Reservoir exhibits much Total Phosphorus. However, there was a large spike of Total Phosphorus at the Midway Bridge during May of 2005. The most likely culprit for this spike is sampling error, since we did not see a corresponding spike downstream from this location.

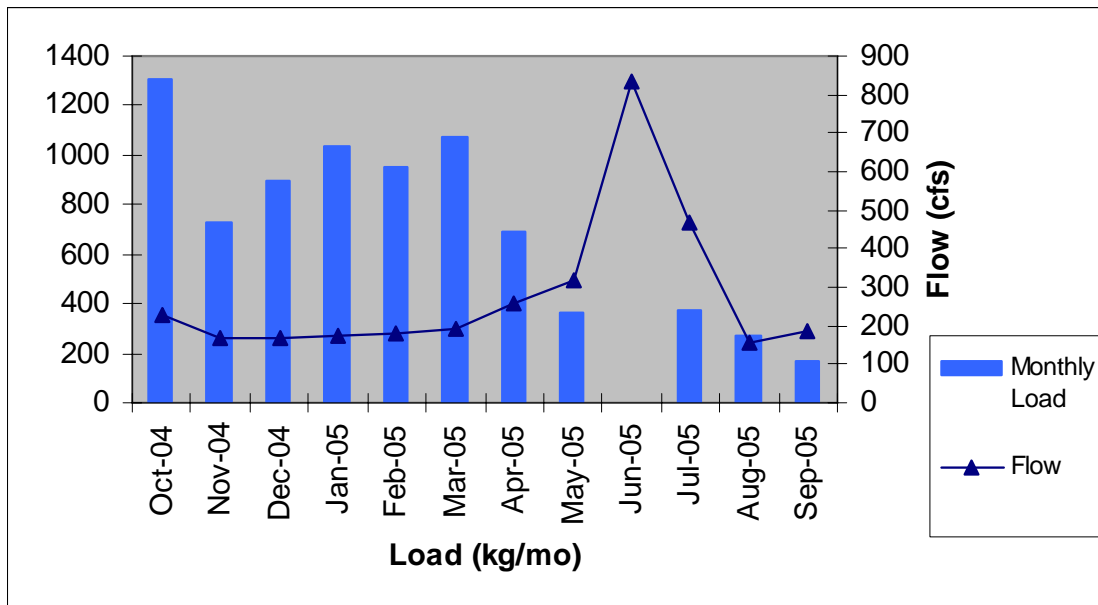
Figure 6 - 2 Monthly Distribution of 2005 TP Loadings in Provo River (above Deer Creek)

Monthly Distribution of Loading in the Provo River are shown in **Error! Reference source not found.** Unusually high loadings occurred in the winter. These loadings are not related to high flows.

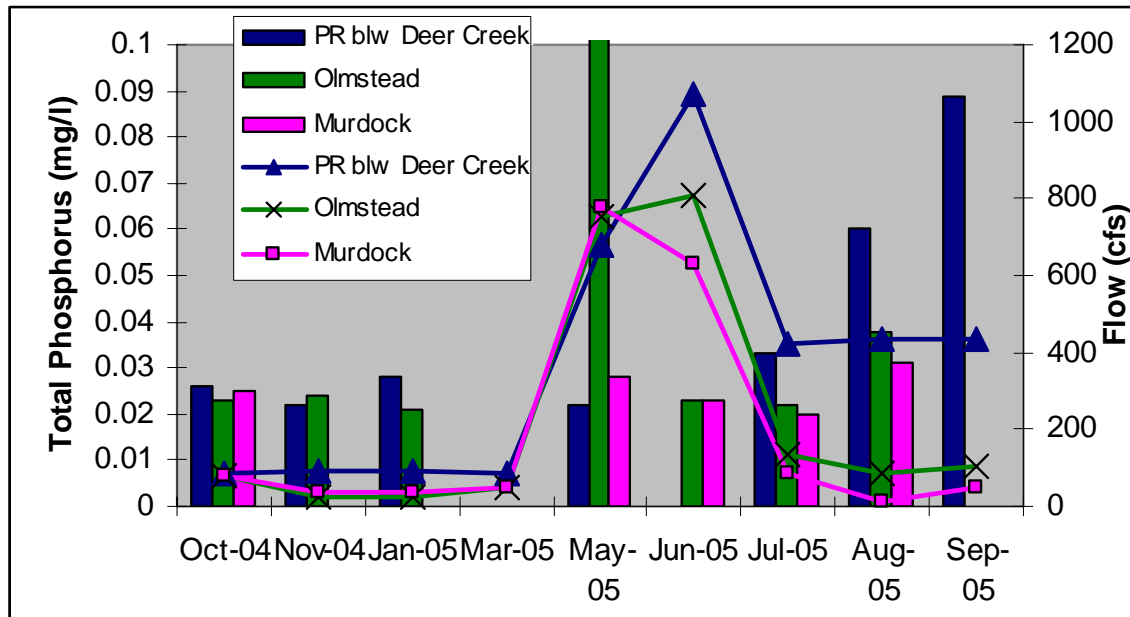
Figure 7 - 1 Provo River Below Deer Creek TP Concentration

Figure 7 - 1 compares the TP concentrations on the Provo River below Deer Creek, Olmsted, and Murdock. This shows that phosphorus concentrations at the three locations were below the PRWC standard for much of the time except for one spike at the Olmsted Diversion (due to South Fork) and the late summer and early fall months below Deer Creek during the reservoir turnover period.
